Chemical Process Safety

Learning from
Case Histories

Third Edition

ROY E. SANDERS

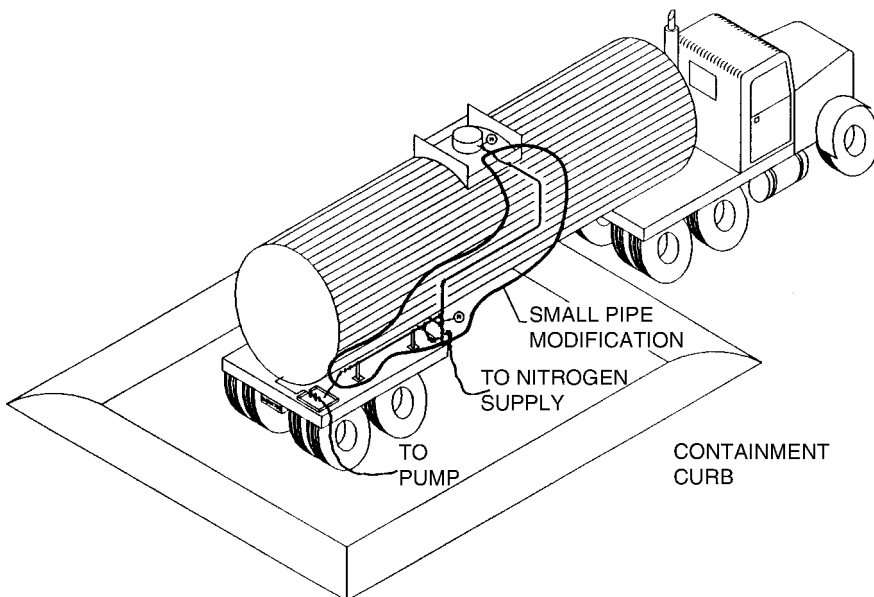
FIGURE 2–3 Tractor and tank truck ready to unload. Courtesy of Manuel David.

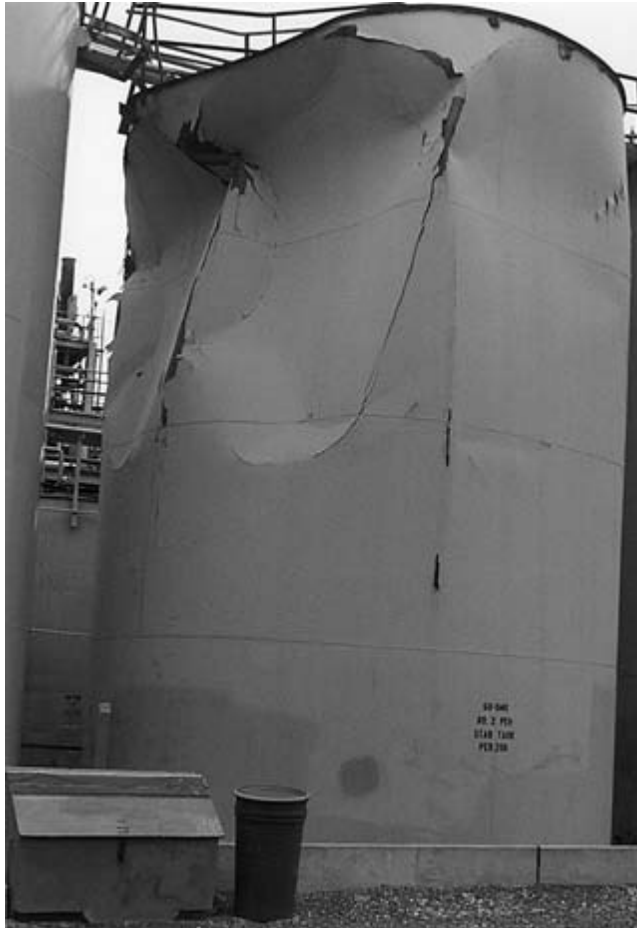
FIGURE 2-13 A 12-ft.-diameter tank ruined after vent system is improved.

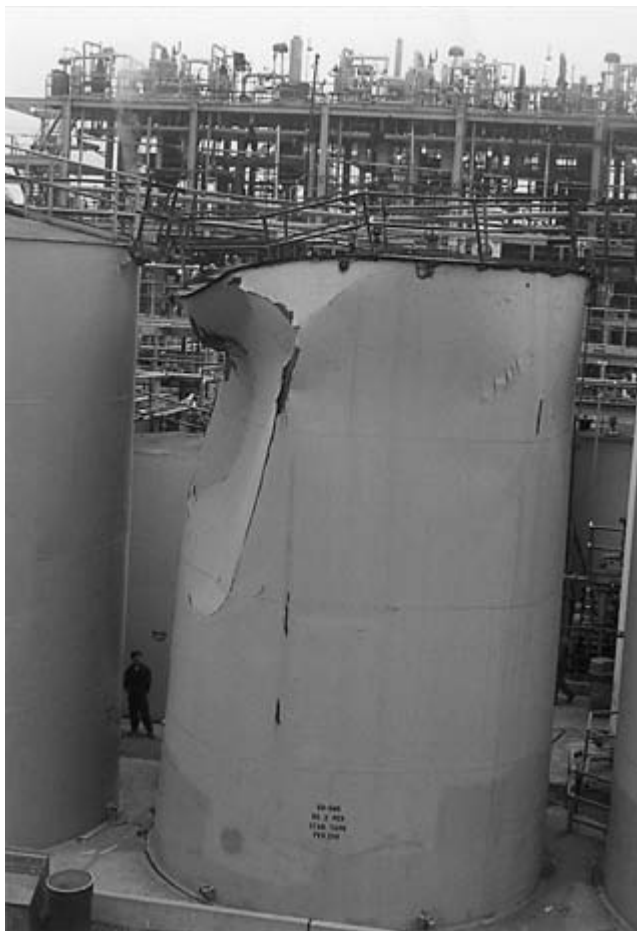
FIGURE 2-16 Crushed tank in the tank farm.

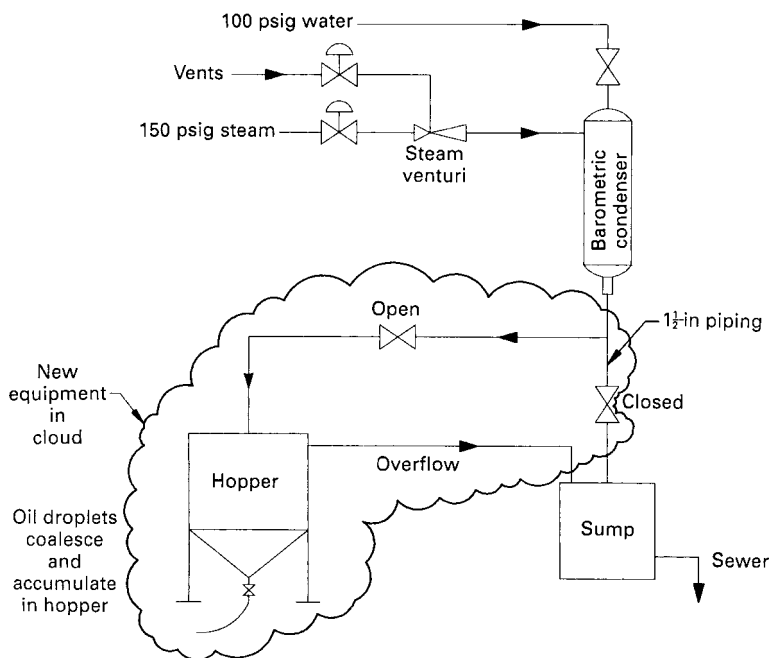
FIGURE 2–17 Modifications on water piping to reduce pollution potentials.
Courtesy of Jack M. Jarnagin.

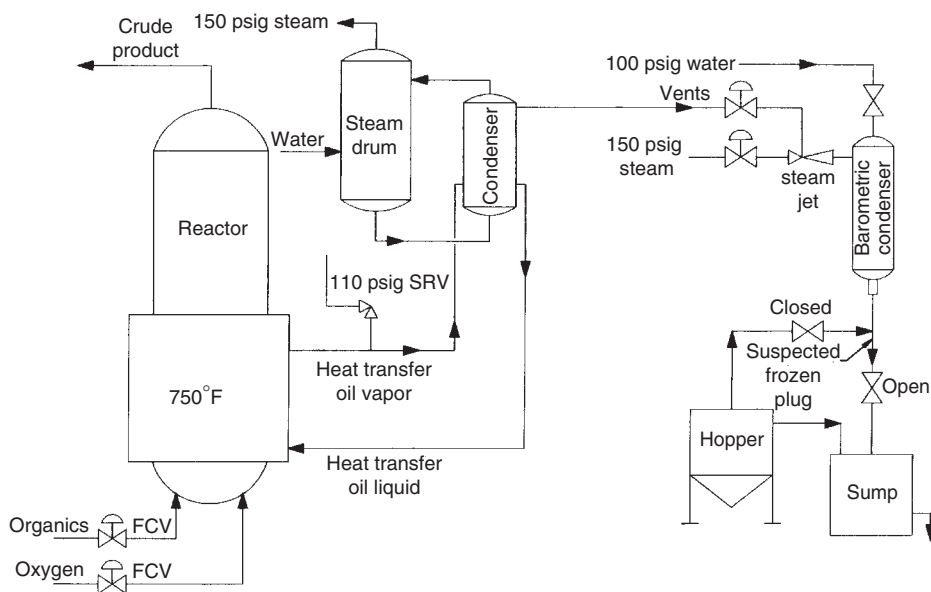
FIGURE 2–18 Solvents reactor system just before the explosion.
Courtesy of Jack M. Jarnagin.

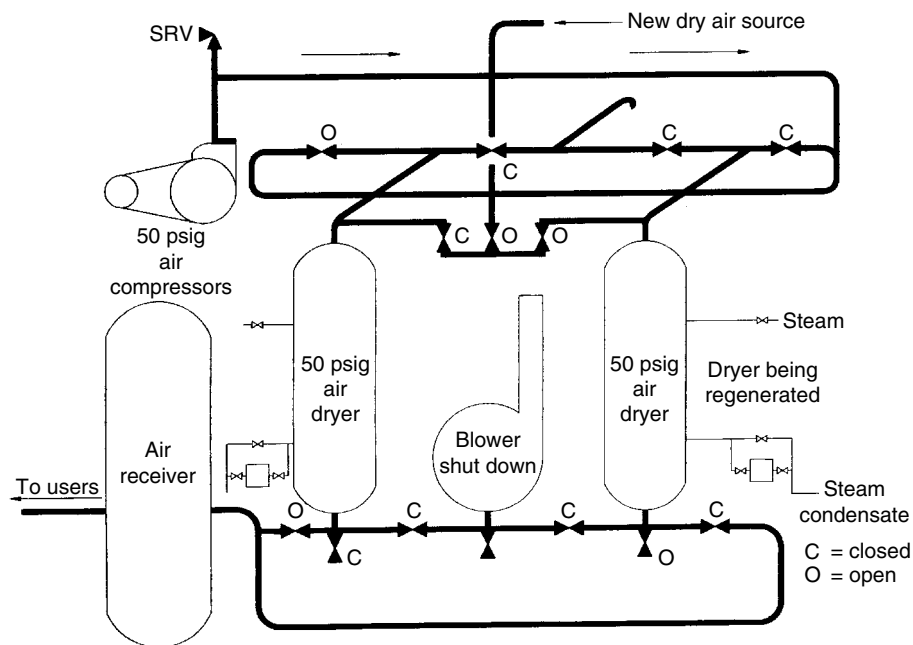
FIGURE 2-20 Modified dryer regeneration sequence at time of explosion.
Courtesy of J. M. Jarnagin.

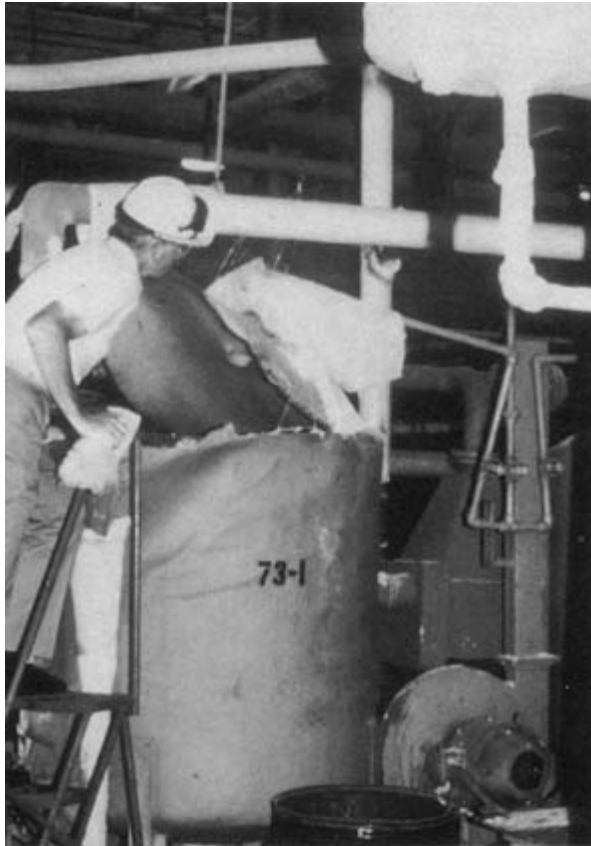
FIGURE 2-21 Employee examines the air dryer failure.

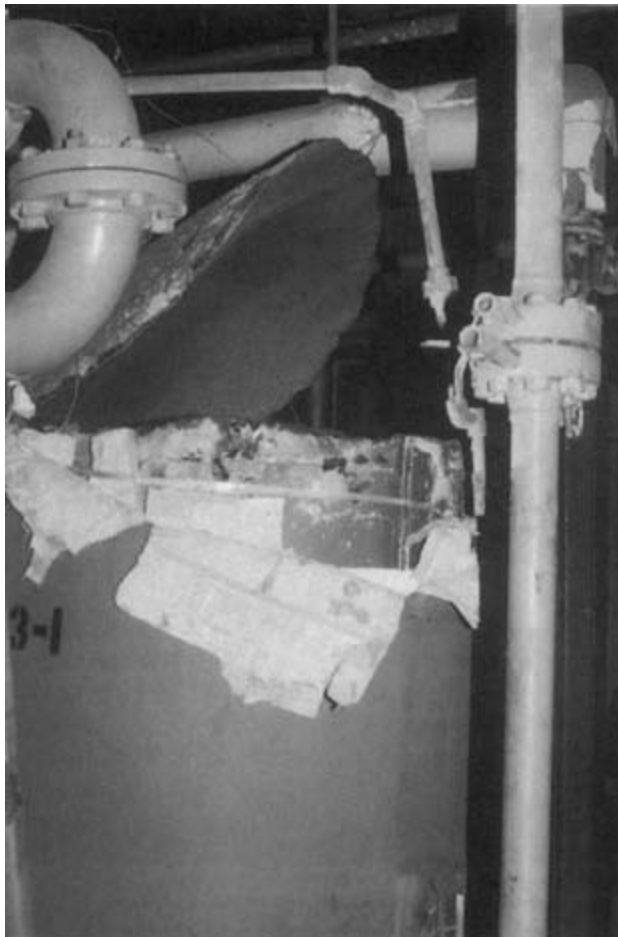
FIGURE 2-22 Close-up of the failed air dryer.

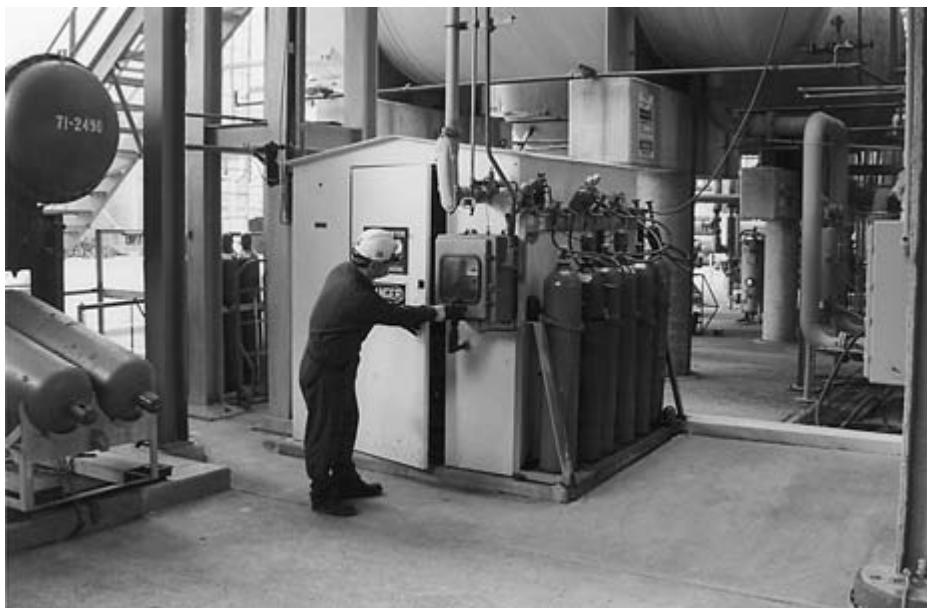
FIGURE 2–23 Typical pressurized and purged analyzer buildings found in chemical plants handling flammables.

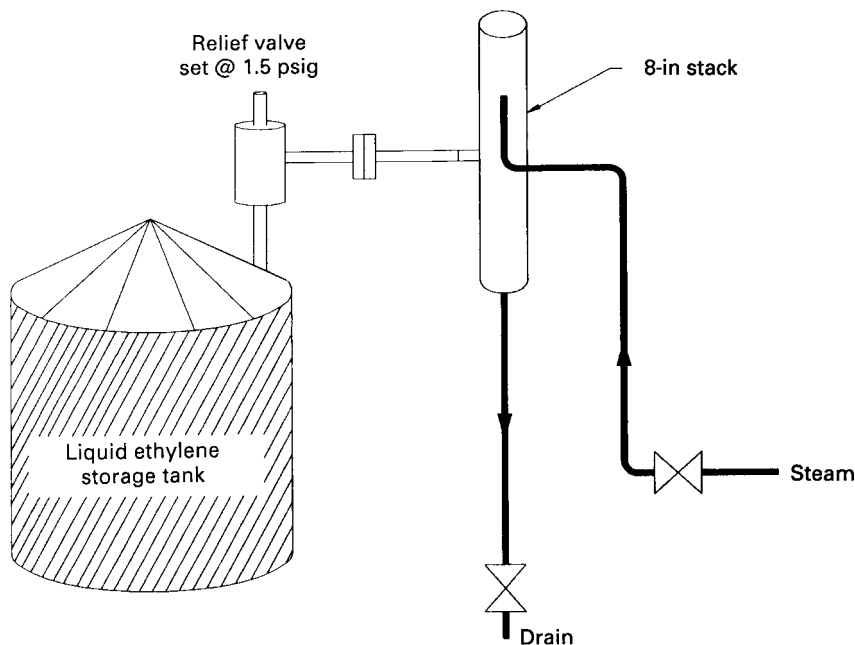
FIGURE 2–25 Well-intended vent modifications. Courtesy of T. A. Kletz.

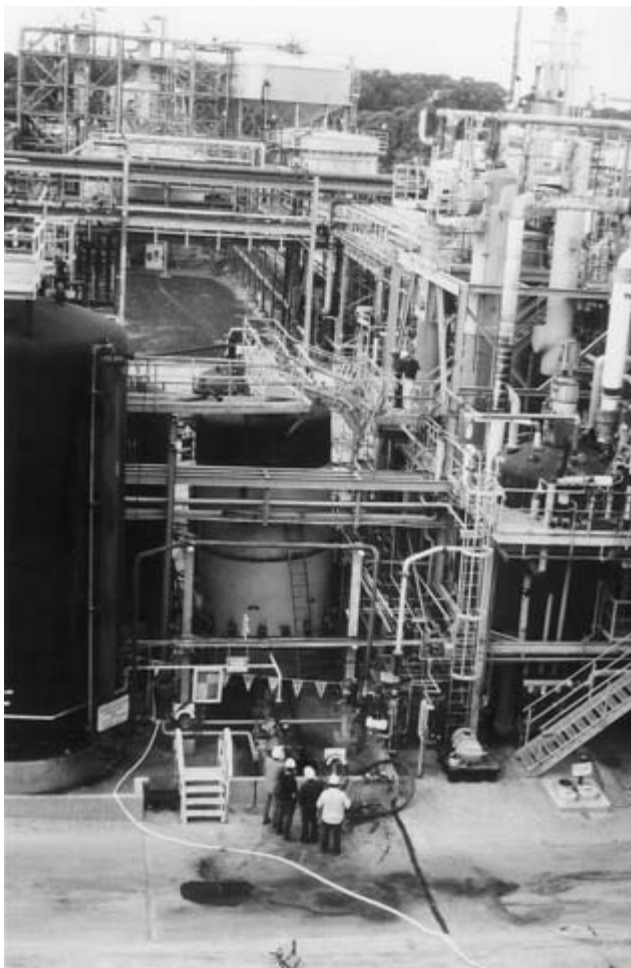
FIGURE 3-1 An API 620 tank is damaged during a hydrotest.

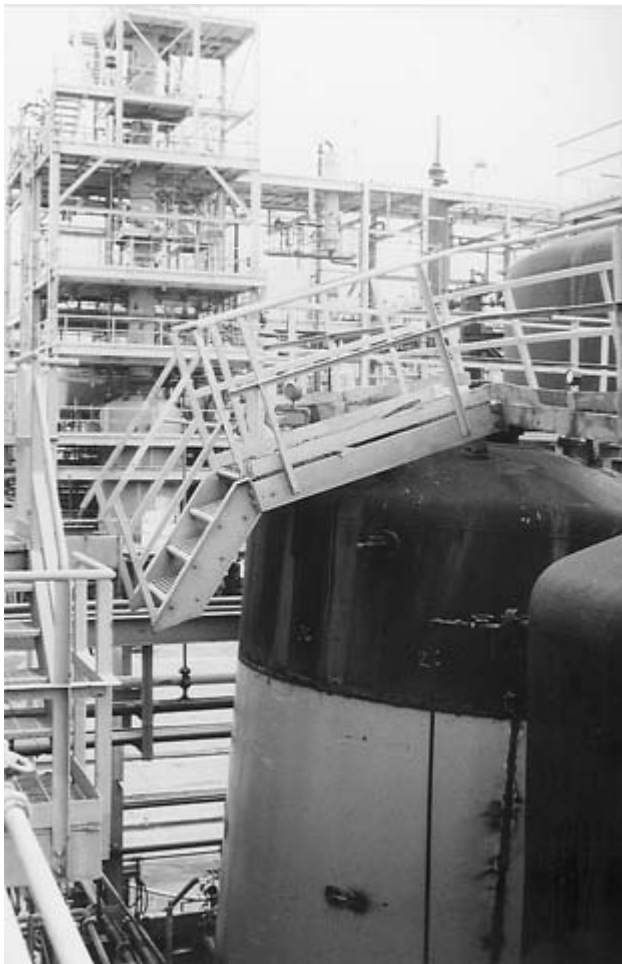
FIGURE 3-2 A closer look at the slightly leaning tank and the walkway that was torn off during the hydrotest.

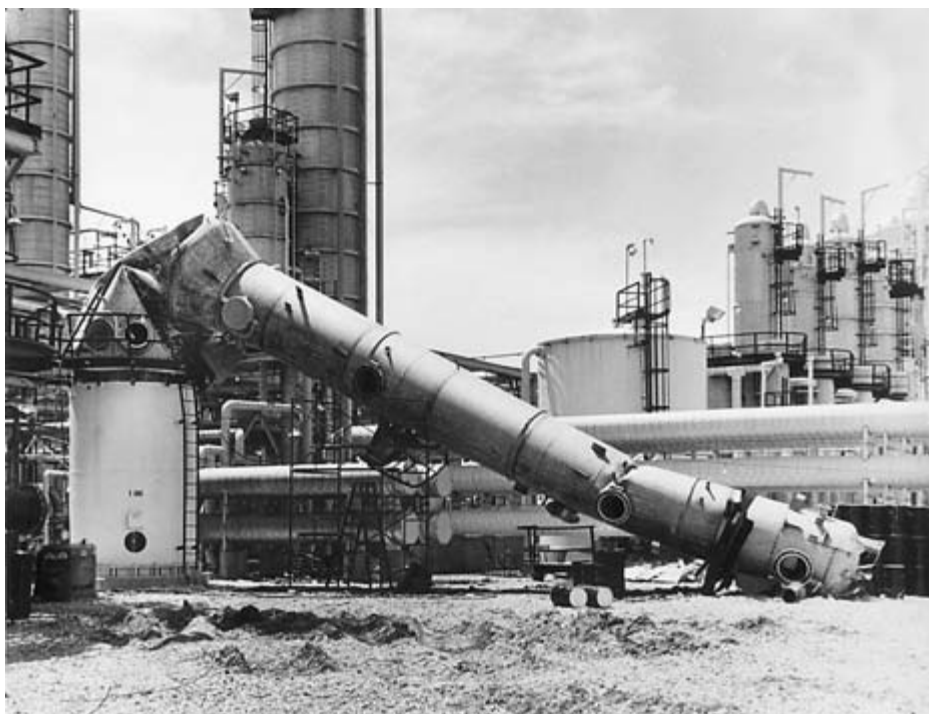
FIGURE 3-5 A stripper column collapses. Courtesy of Guido DeJesús.

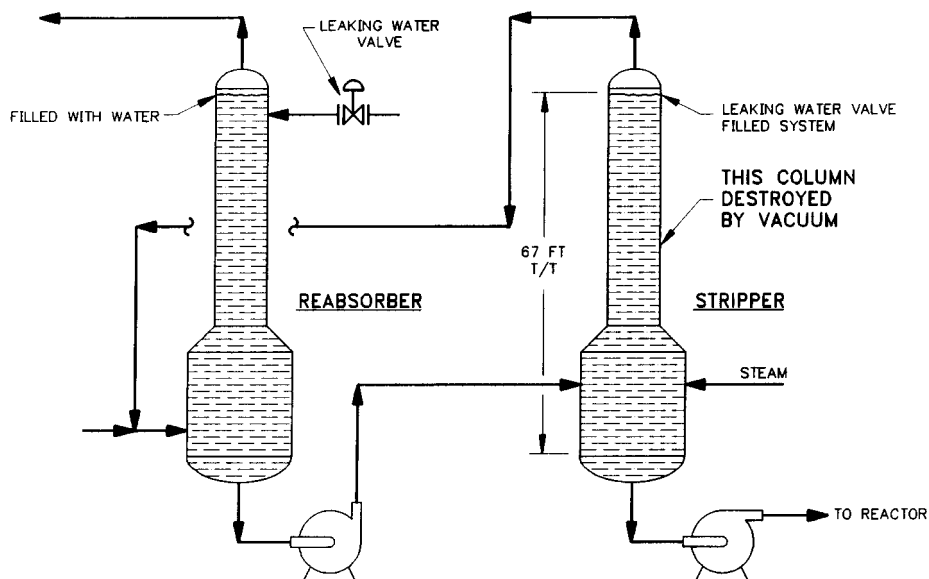
FIGURE 3-6 The design of the reabsorber/stripper system. Courtesy of Guido DeJesus and Warren Schindler.

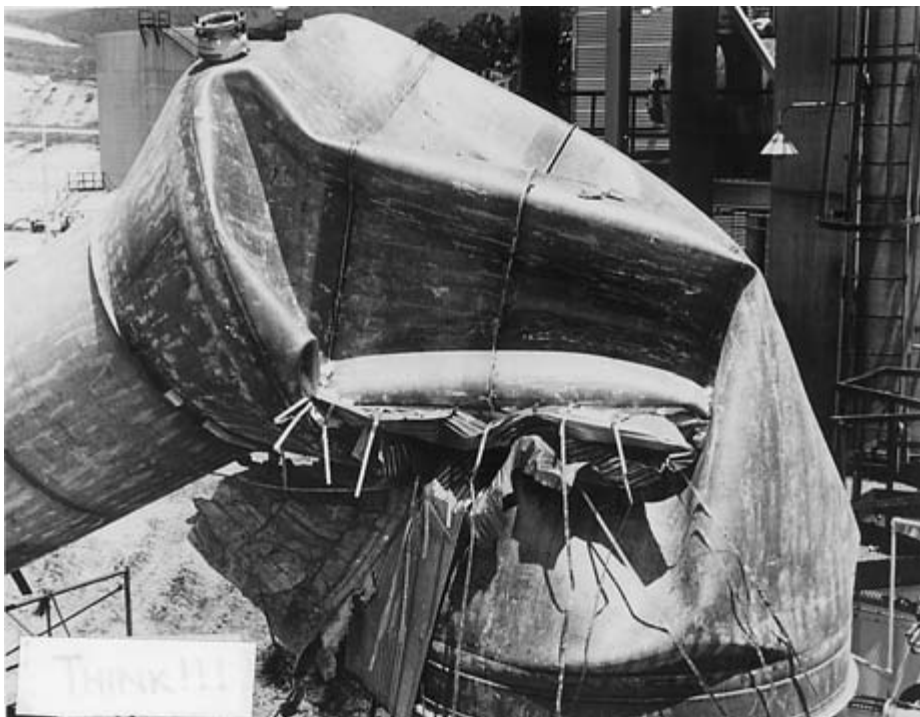
FIGURE 3-7 A close-up of a collapsed stripper column.
Courtesy of Guido DeJesus.

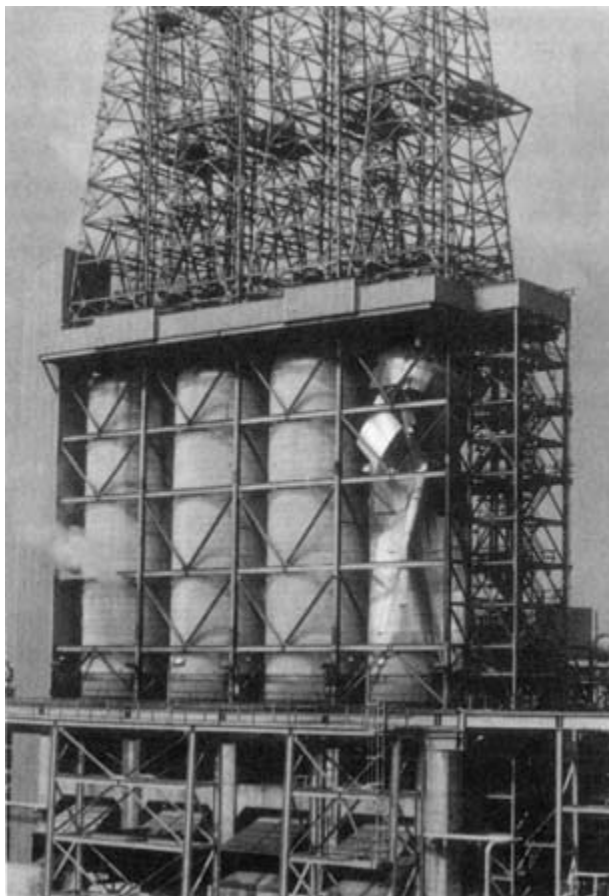
FIGURE 3–9 Collapsed coker drum in a refinery. Courtesy of S. O. Kapenieks.

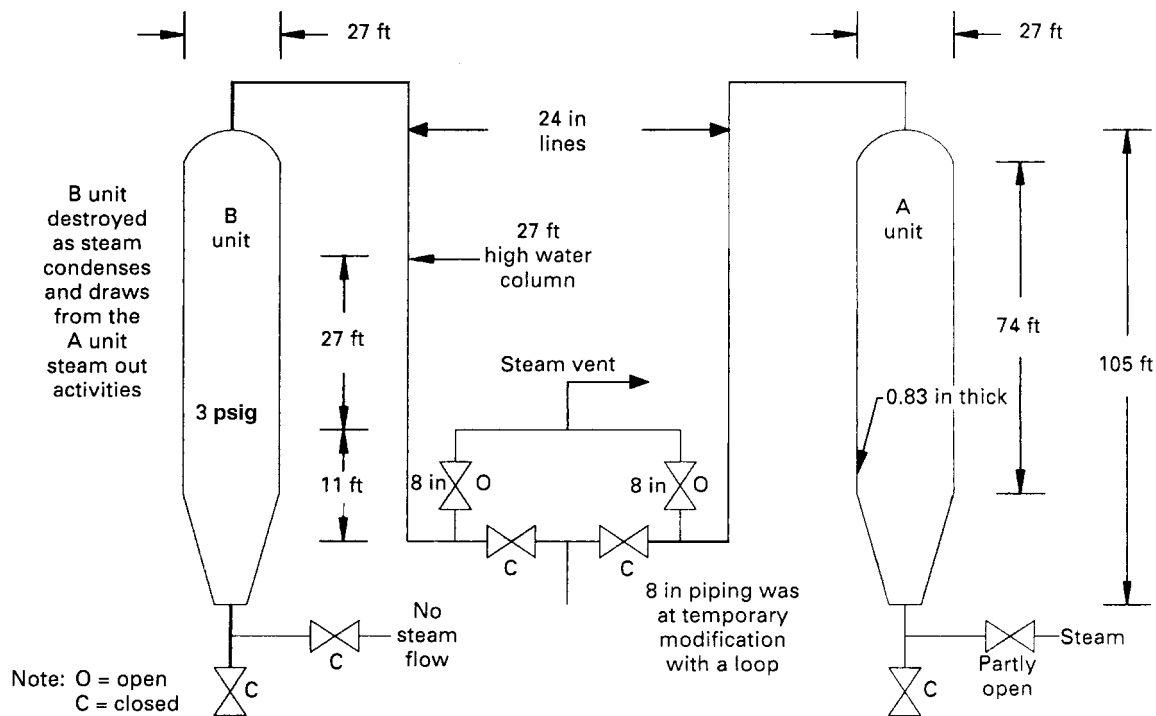
FIGURE 3-10 Conditions at the time of the failure of the coker drum.

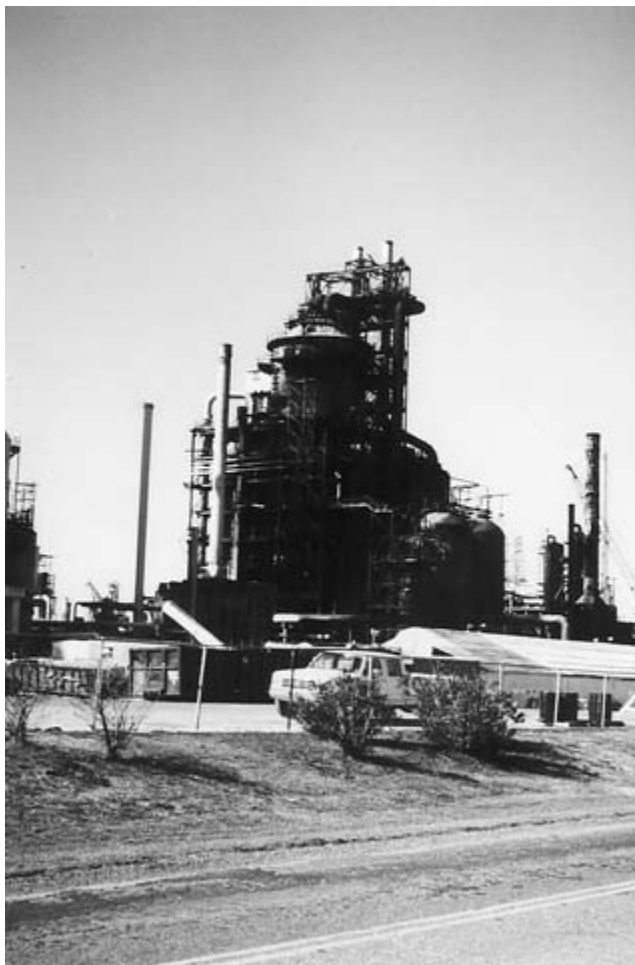
FIGURE 3–12 After the explosion, a charred multi-storied catalytic cracking unit.

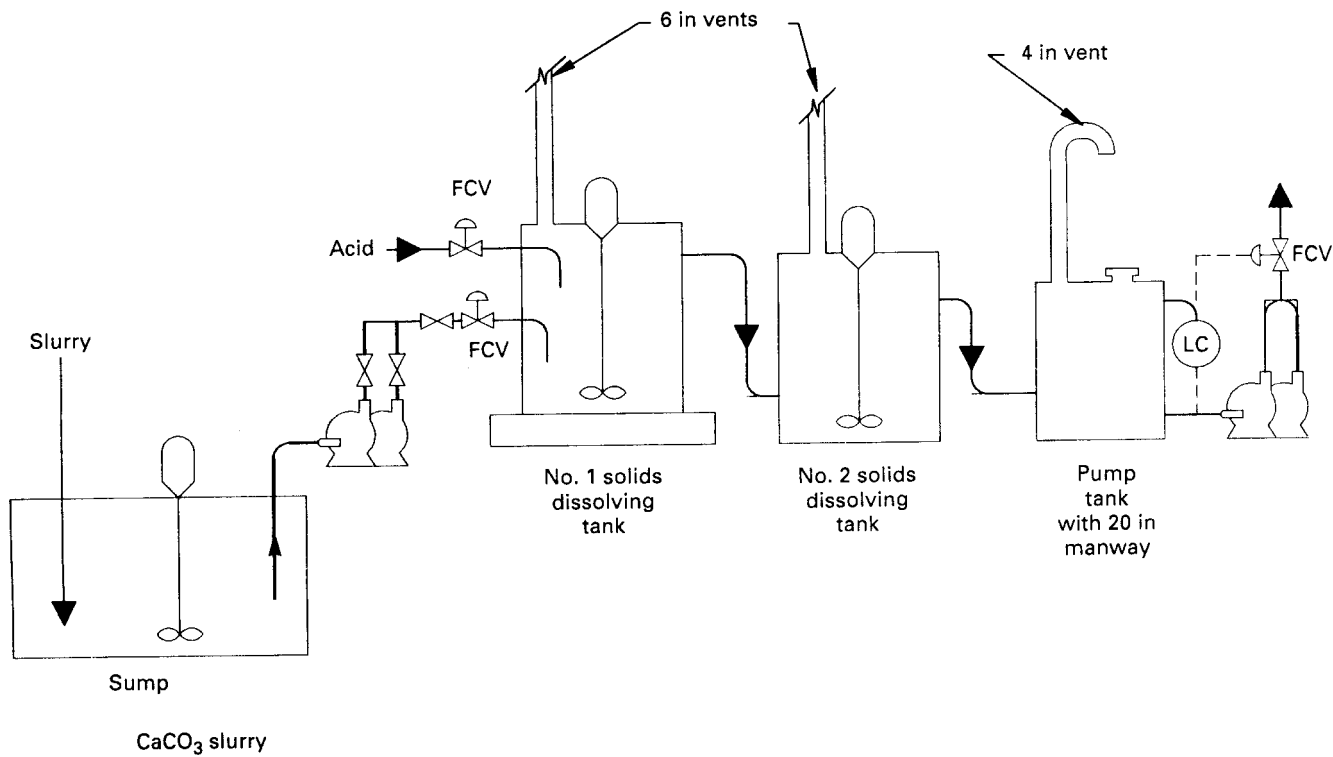
FIGURE 4-3 Slurry-dissolving system. Courtesy of J. M. Jarnagin.

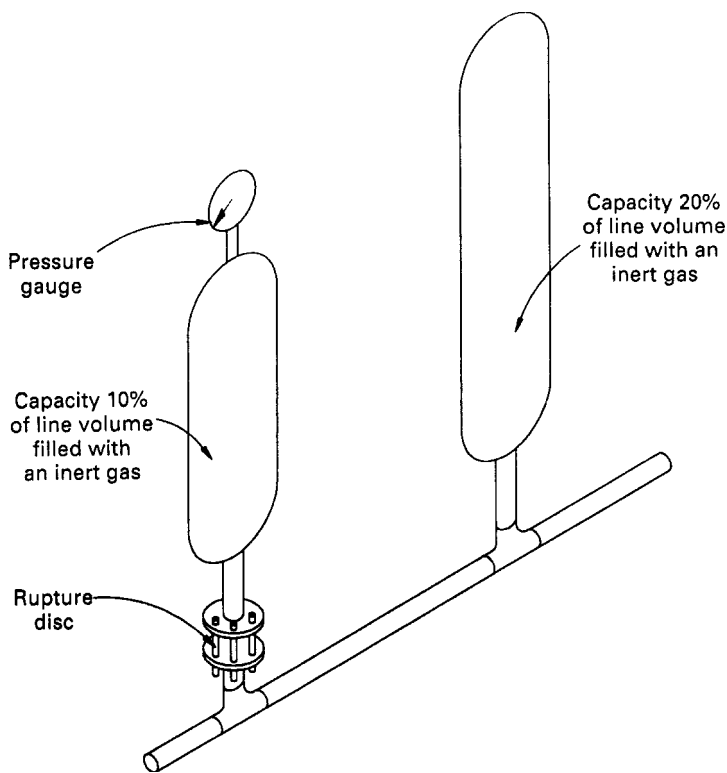
FIGURE 4-4 Expansion chambers for liquid chlorine pipeline protection. Courtesy of the Chlorine Institute, Inc.

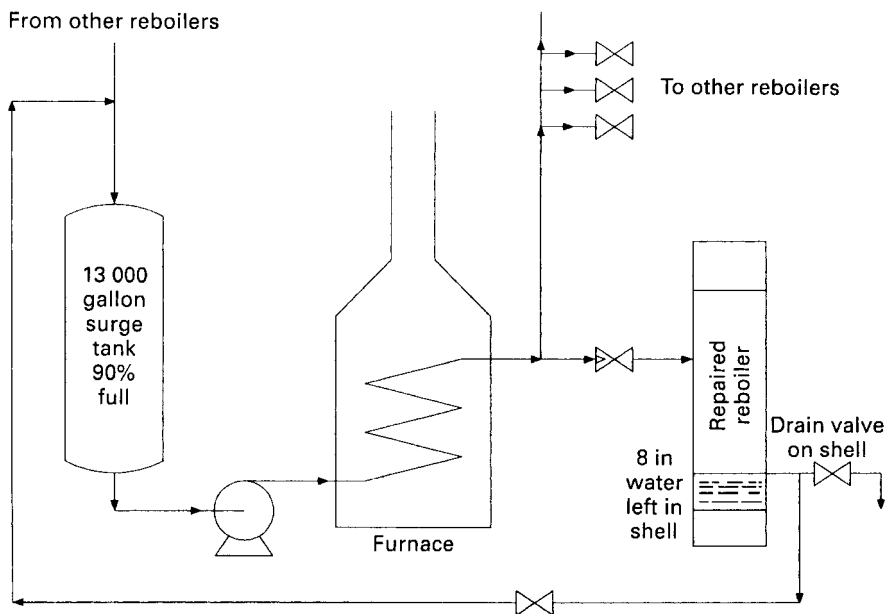
FIGURE 5–1 Residual, undetected water from a hydrotest explosively vaporizes and ruptures a surge tank. Courtesy of Trevor A. Kletz.

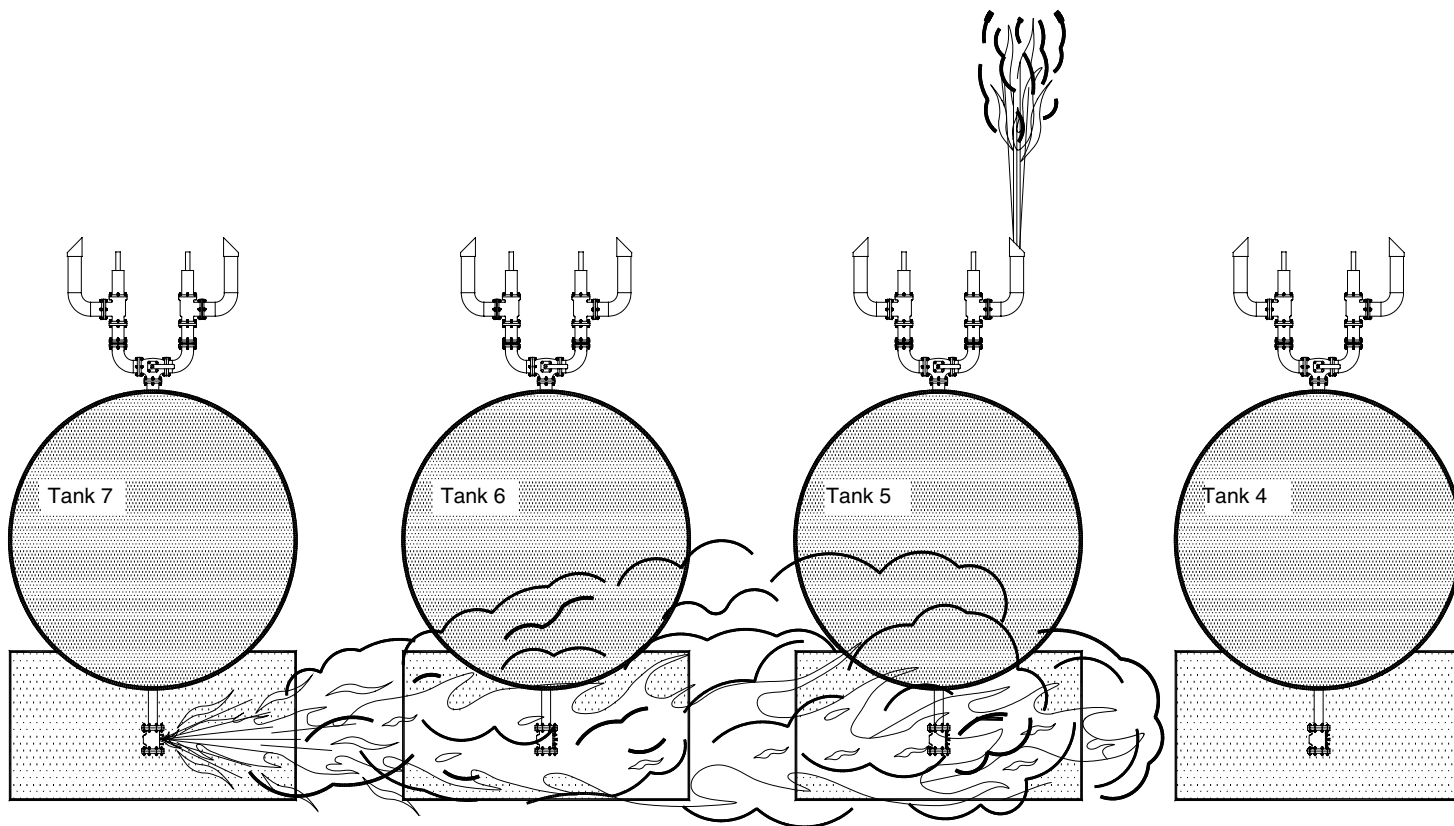
FIGURE 5-9 Flames Below the Vinyl Chloride Tanks—An Artist's Perception. Courtesy of Manuel David.

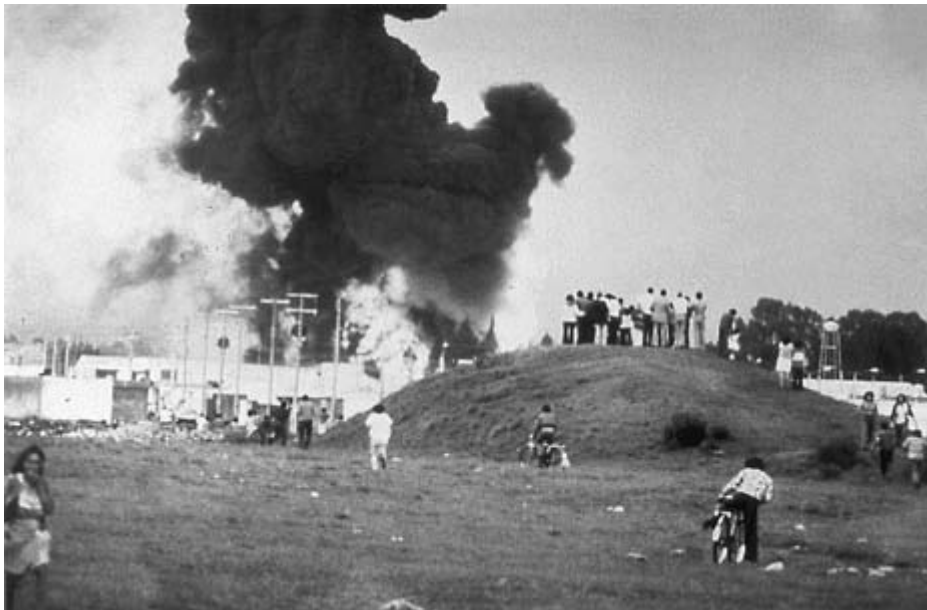
FIGURE 5-10 BLEVE of a vinyl chloride storage tank. Courtesy of the Institution of Chemical Engineers.

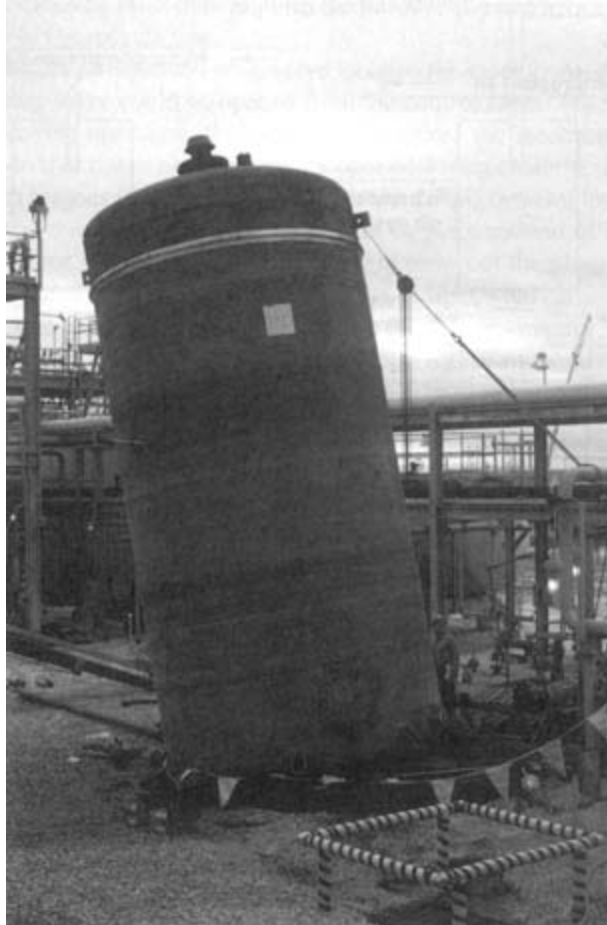
FIGURE 5–12 A large acid tank fails due to blocked vent and a blocked overflow line.

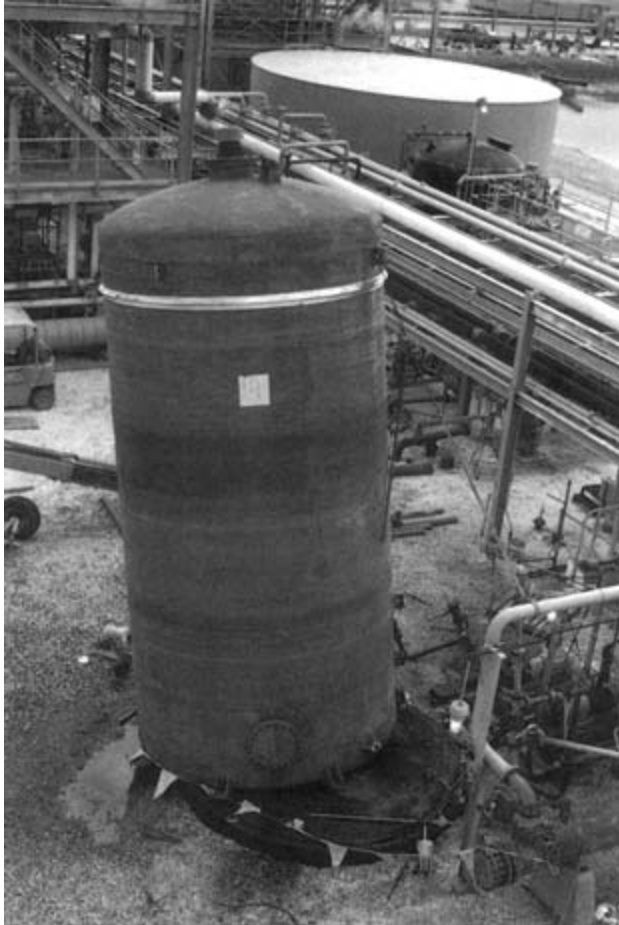
FIGURE 5-13 An aerial view of the tank failure.

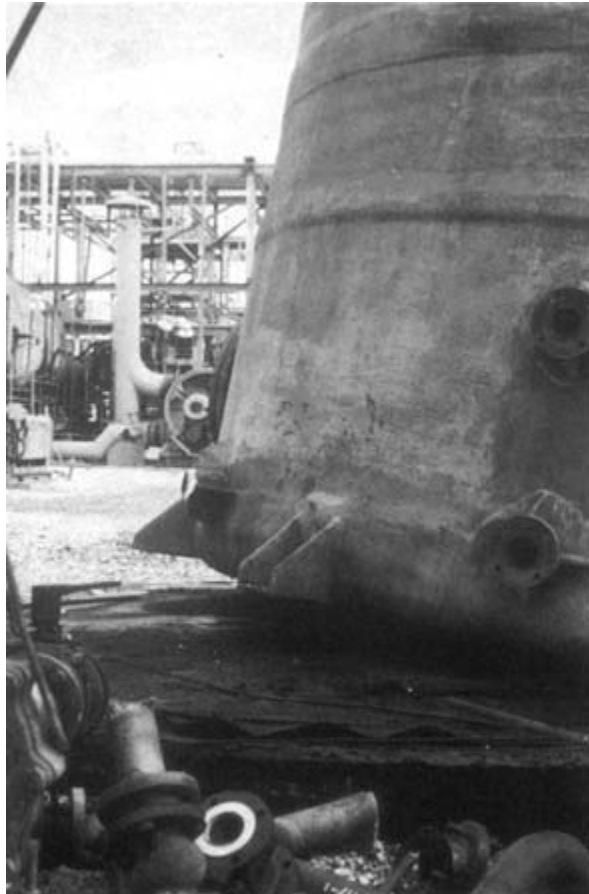
FIGURE 5-14 A close-up of the failed tank base.

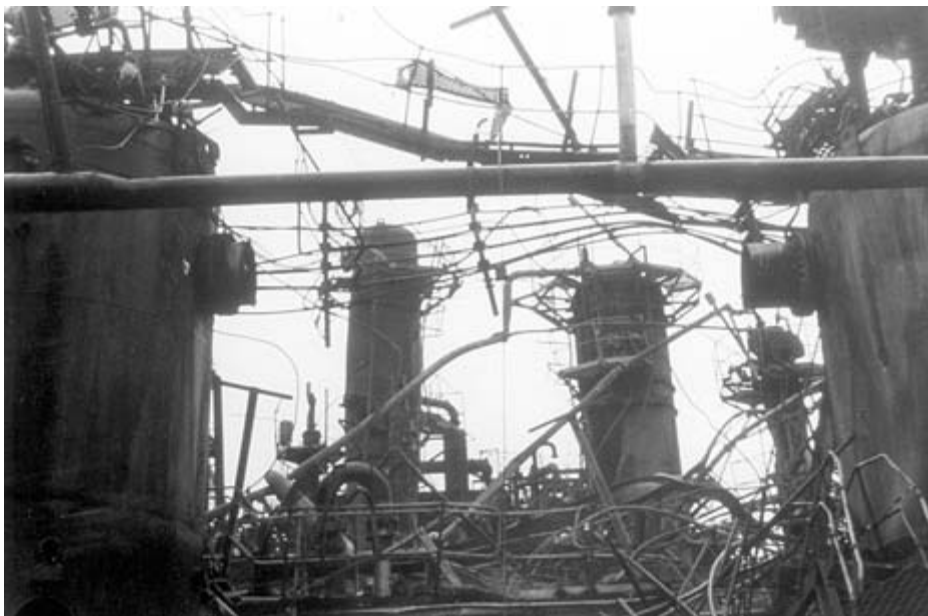
FIGURE 5-16 A Destroyed Section of the Flixborough Reactor System.
Photo courtesy of Trevor A. Kletz.

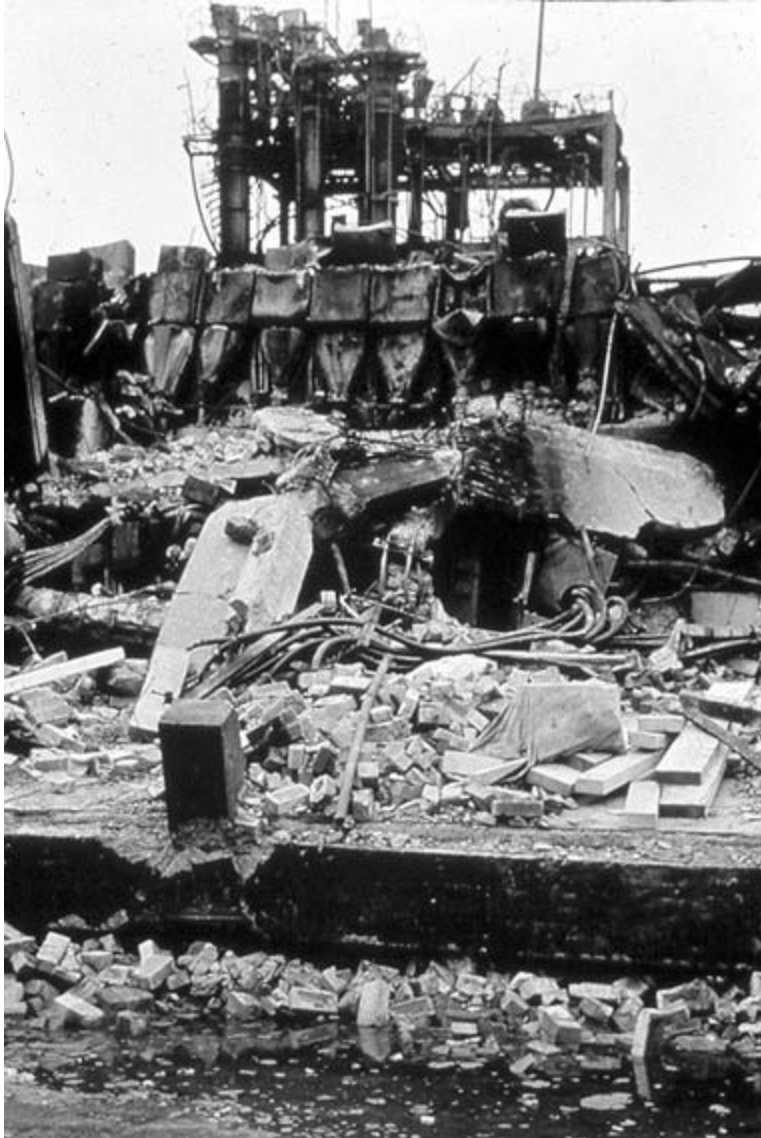
FIGURE 5-17 The rubble of the crushed control room at Flixborough. Courtesy of Trevor A. Kletz.

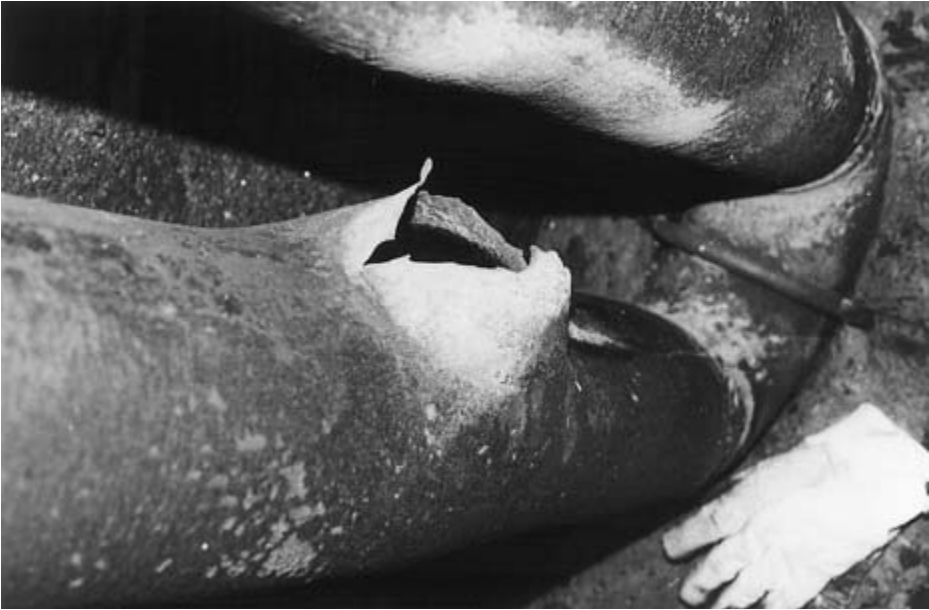
FIGURE 6-2 Tube rupture in a fired heater.

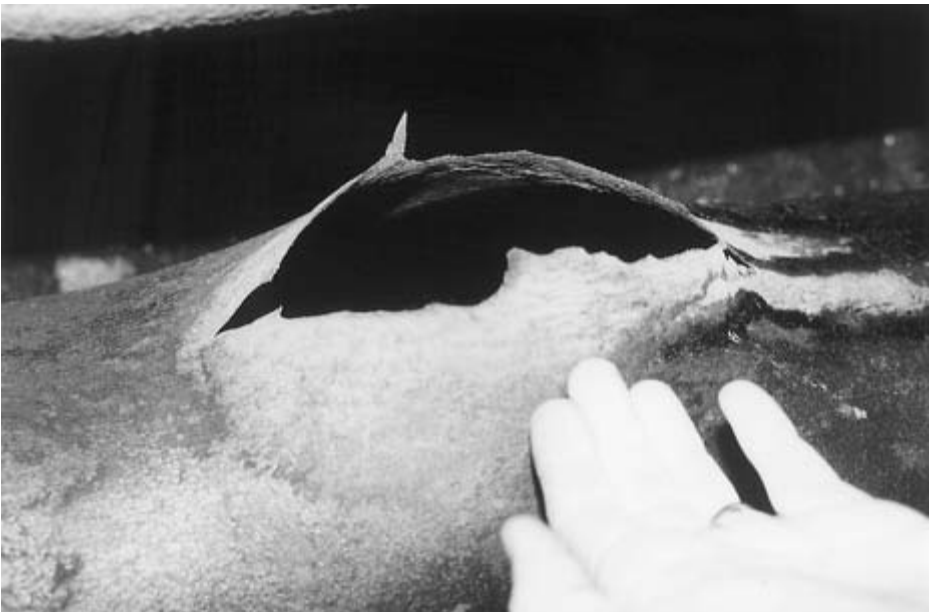
FIGURE 6-3 Close-up of the tube failure.

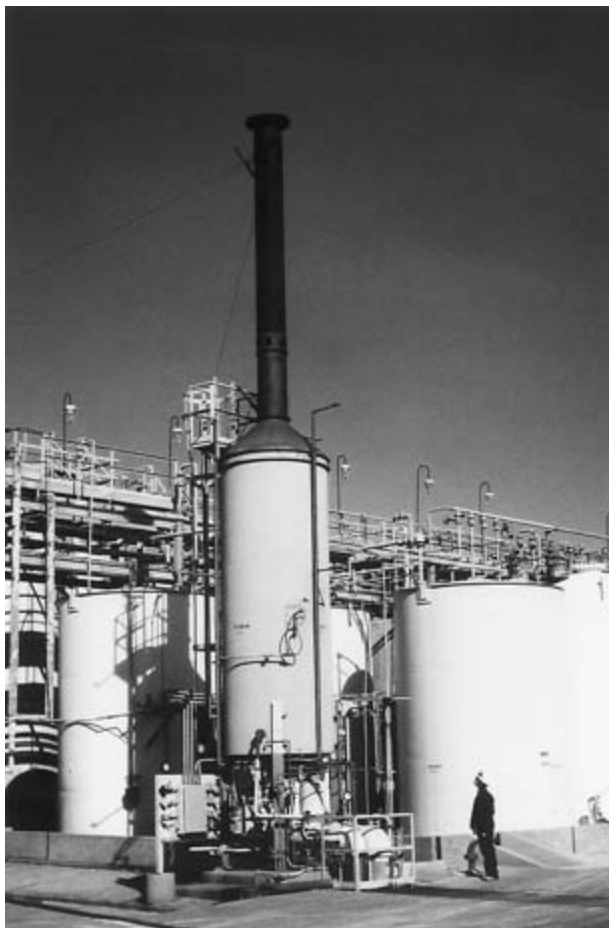
FIGURE 6-4 The rejuvenated and relocated gas-fired heater.

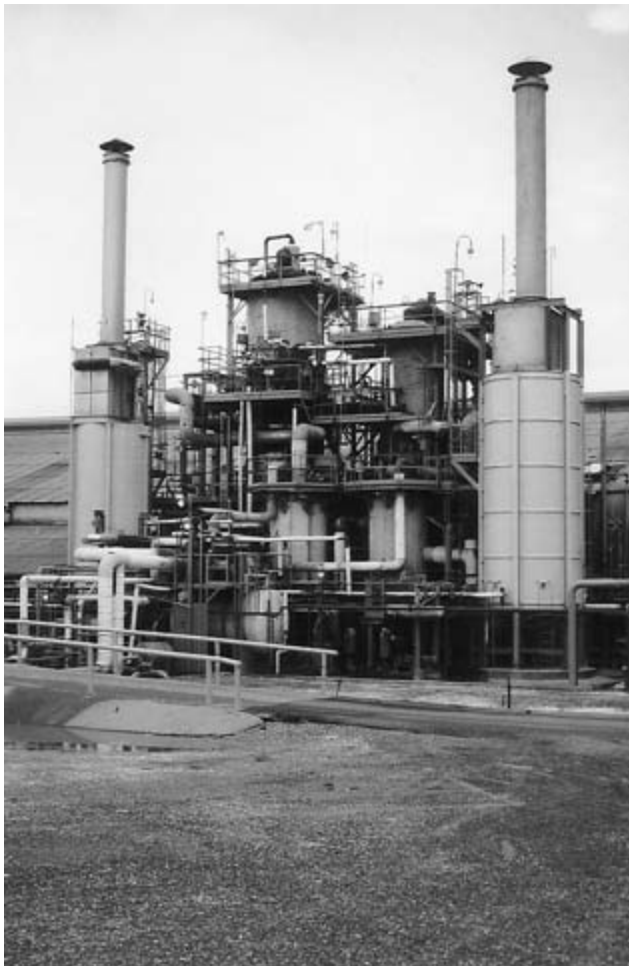
FIGURE 6-5 Well-maintained unit is troubled by a leak.

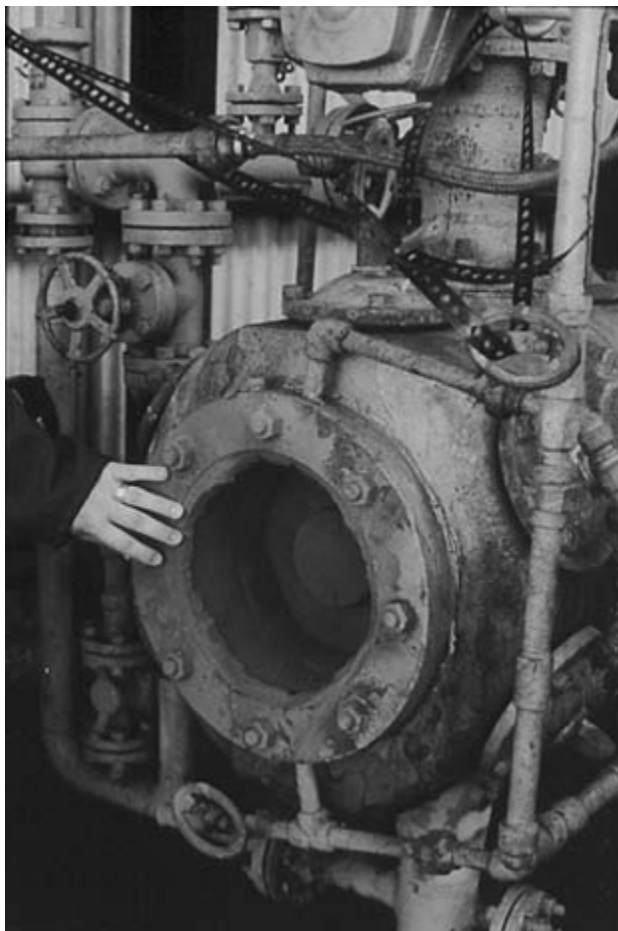
FIGURE 7-2 Close-up of ruptured water jacket on compressor.

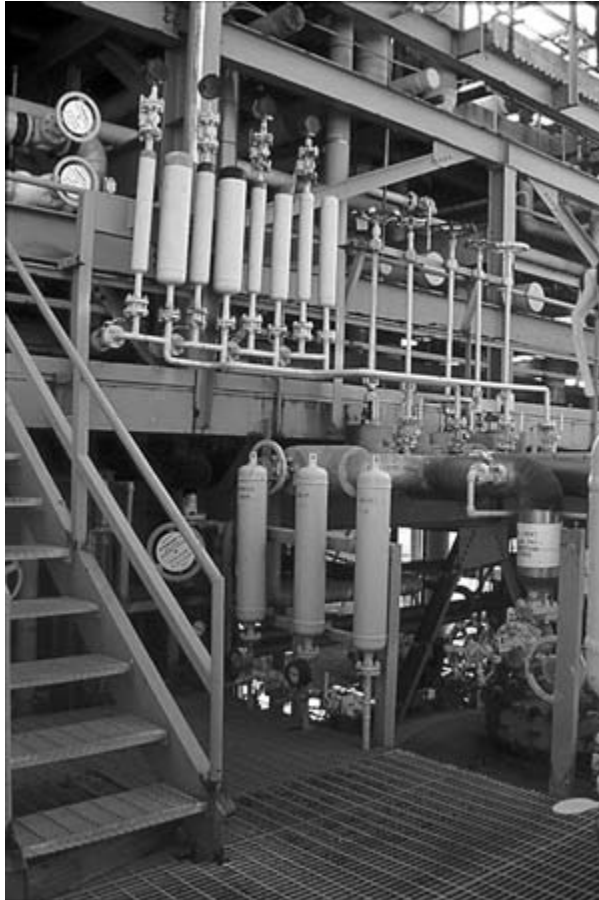
FIGURE 7-5 Expansion bottles protecting piping from overpressure.

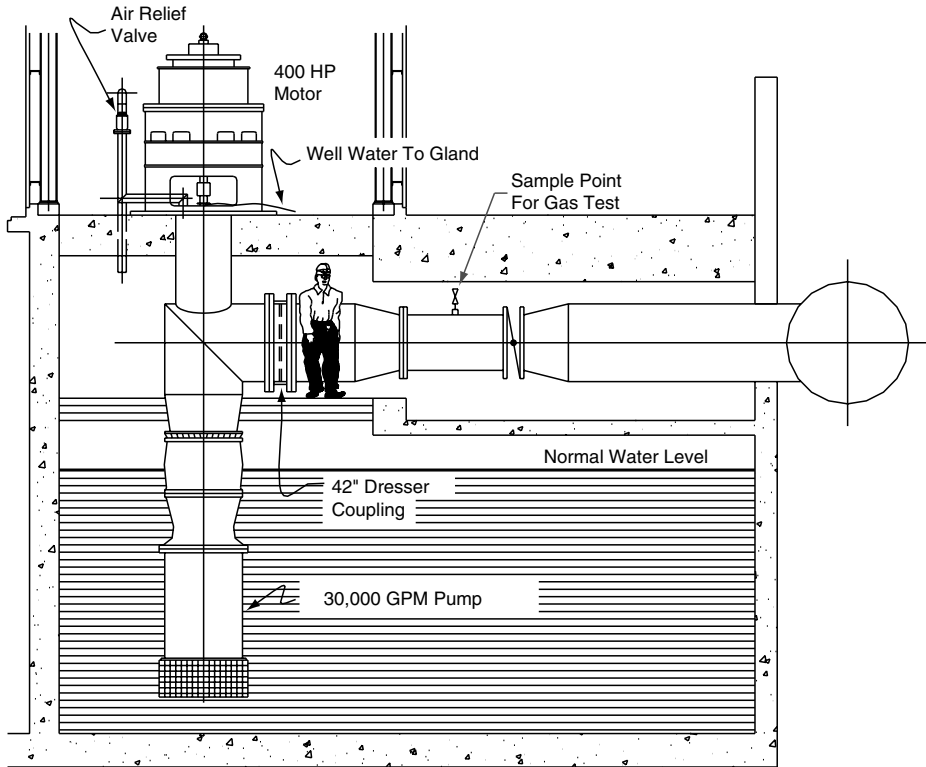
FIGURE 7-8 Sketch of the river water pump system at normal conditions. Courtesy of Manuel David.

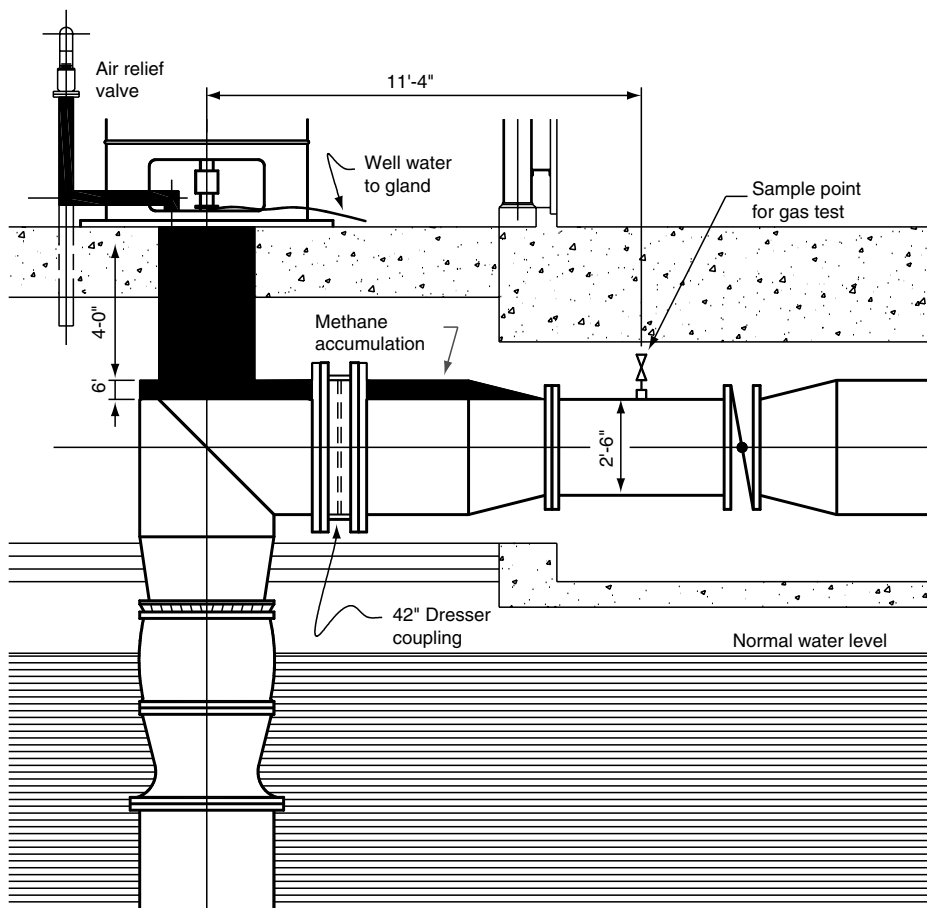
FIGURE 7-11 Sketch of how methane gas accumulated in the river water piping.
